FLANGE TOOL INNOVATION

CASE STUDY

CS-2013-02

LIFTING FPSO HANG-OFF BEND RESTRICTOR FLANGES TO ACCESS CORRODED HYDRAULIC HOSES

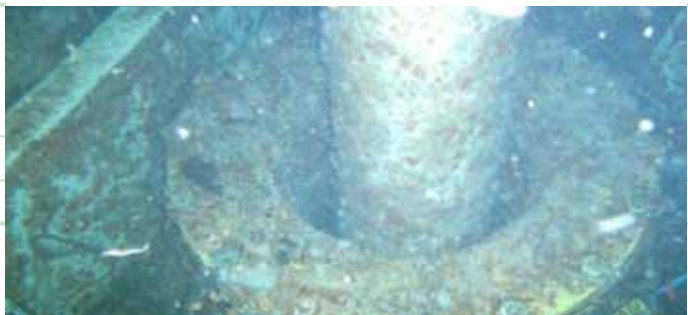
were found to lack the nylon spacer rings which should maintain a flange access gap. As a result the hang-off units had dropped so that the flanges were face-to-face, and heavily corroded together.

Dive teams had been unable to spread some of the hang-off unit flanges due to their being insufficient gap available for the normal spreading wedges to be employed. The spreading force was unknown, though the weight of the hang-off including the bend-restrictor was thought to be around 10T. Heavy corrosion was suspected, so it was feared that considerable force would be required to break the initial adhesion between the flange faces.

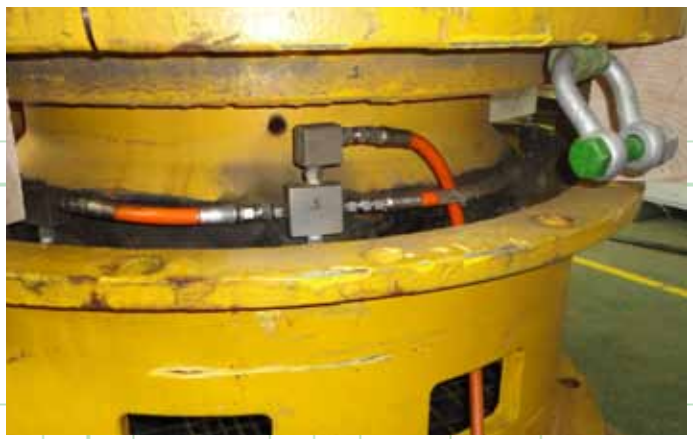
The MG7TM Mini-Gap flange spreader was proposed for the flanges where some degree of access gap was apparent, or where an initial gap had already been achieved. Three of the tools were recommended to be installed equally spaced around the flange, and the tools were intended

to create sufficient gap for the SW15TE tools to be installed, 6mm.

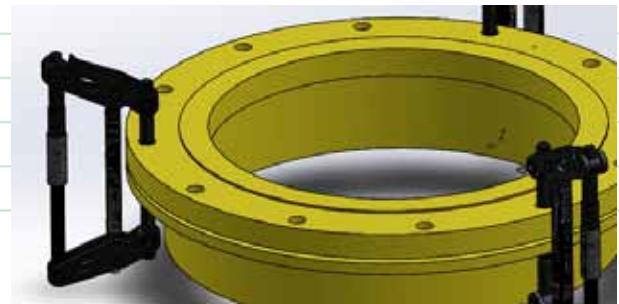
The SG11TM tool was proposed for the flanges where no access gap was apparent. Three of the tools were recommended to be installed equally spaced around the flange. The lower flange was only 25mm thick, so in-house

prototype bolt-holes were created and testing was carried out to ensure the collets would grip effectively into such a short bolt-hole area.
